Inspection Report

Minerals Regulatory Program

Mine Name: White Cap #8
Operator Name: Gypsum Resource Development

Permit number: S/015/047
Inspection Date: January 20, 2006
Time: 10:50-11:30 AM

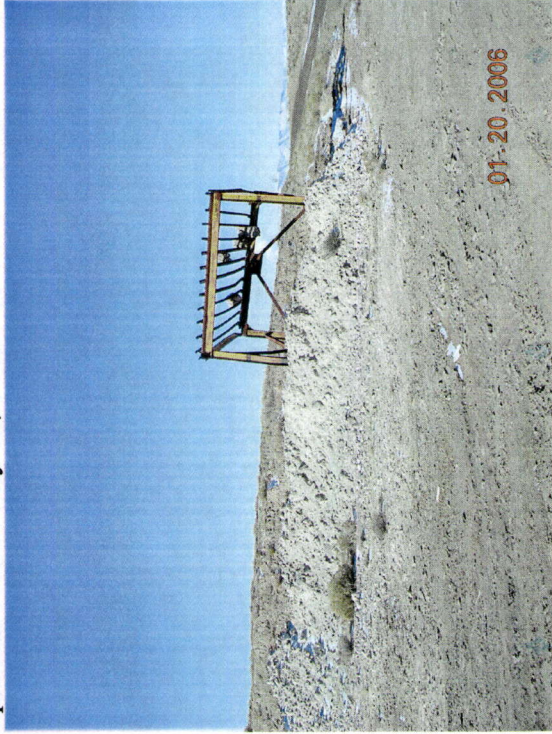
Photo 2. Grizzly near the county road.

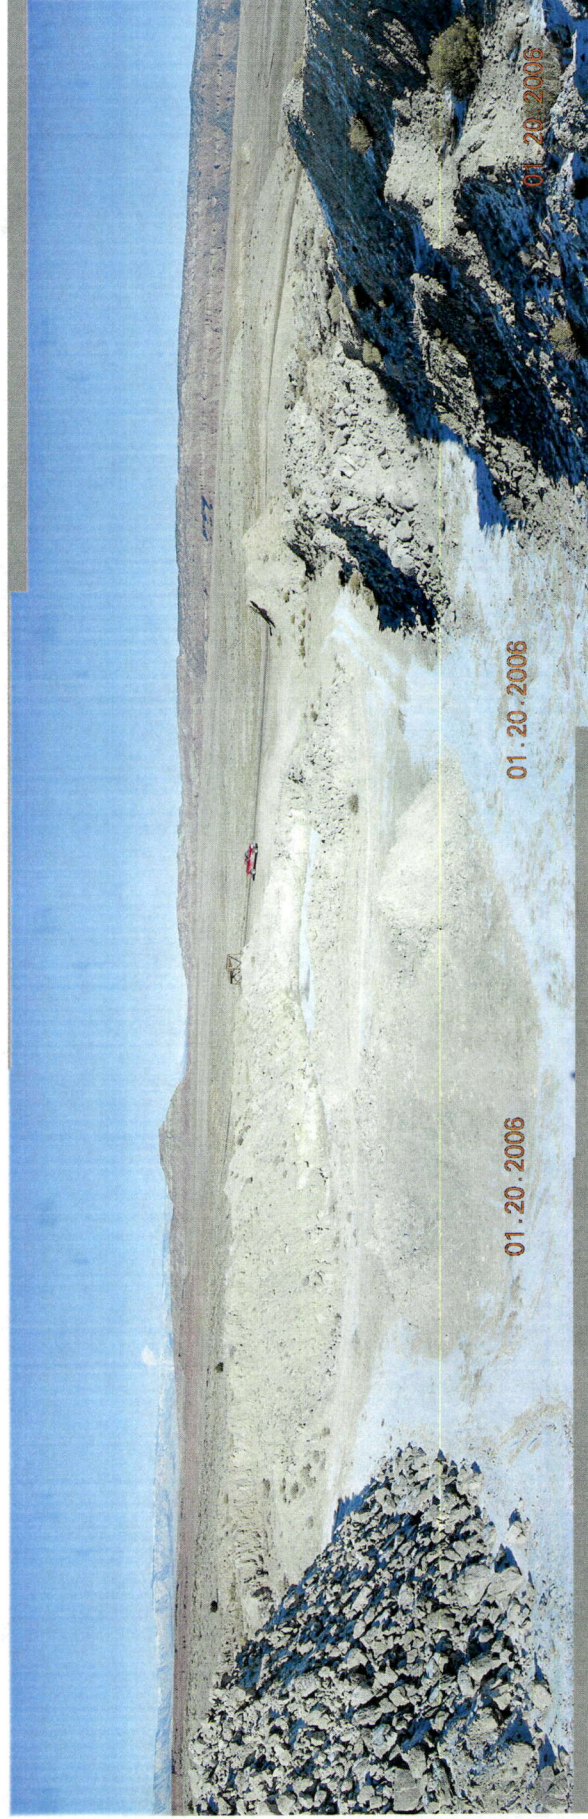
There is a pond near the road that contains water.

Photo 3. Panorama of the lower part of the quarry. Note the pond containing water (ice). On the left is the largest of a few gypsum stockpiles.

Regrading this site should not be terribly complicated. Stockpiles will need to be graded into the pond and other low areas. As mentioned above, this will create a swale, but it should be possible to have positive drainage. Basic grading should be followed by topsoil placement. Topsoil was stockpiled around the perimeter of the site.

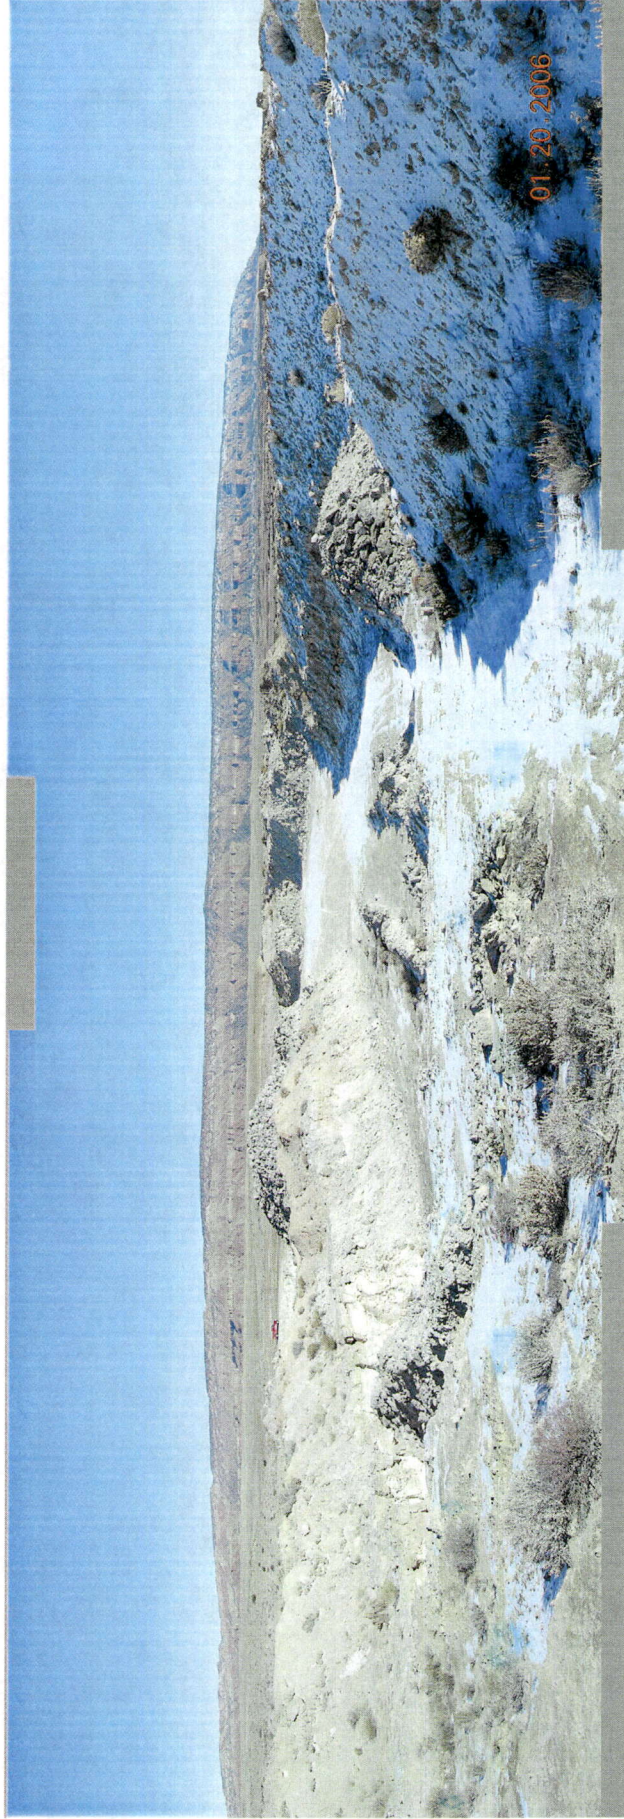
Photo 4. Another panorama of the quarry. These pictures were taken from the southern edge of the disturbed area.
